PRELIMINARY ASSESSMENT FOR THE FRED'S AUTO JUNKYARD SITE LOWER PROVIDENCE TOWNSHIP, MONTGOMERY COUNTY, PENNSYLVANIA DUMP SITE NO. PA-3017 EPA ID NO. PAD987378213

EPA WORK ASSIGNMENT NO. 85-12-3JZZ CONTRACT NO. 68-W8-0085

December 1993

Ecology and Environment, Inc. Philadelphia, Pennsylvania

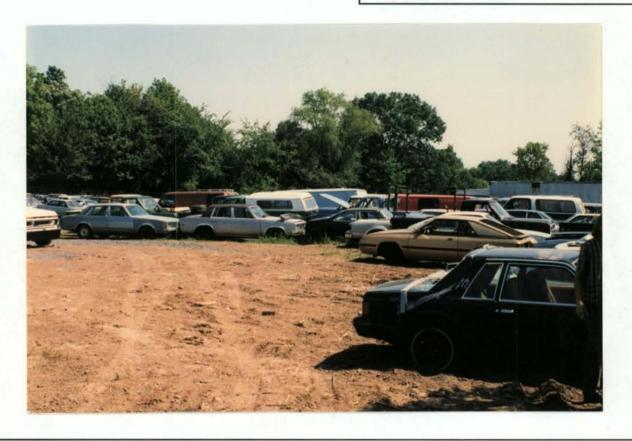
ecology and environment, inc. PHOTOGRAPHIC RECORD		
Client: EPA Region III	E & E Job No.: ZE5629	
Site: Fred's Auto Junkyard		
Camera: Make Pentax	SN 4759340 (EPA Decal 897603)	
Lens Type 50 mm	SN 367638	
	Photographer: J. McCall Date: 8/26/93	
	Time: 1138 Frame No.: 4	
	Comments*: View of area in which mobile automobile	
	crusher is used.	
	*Comments to include location.

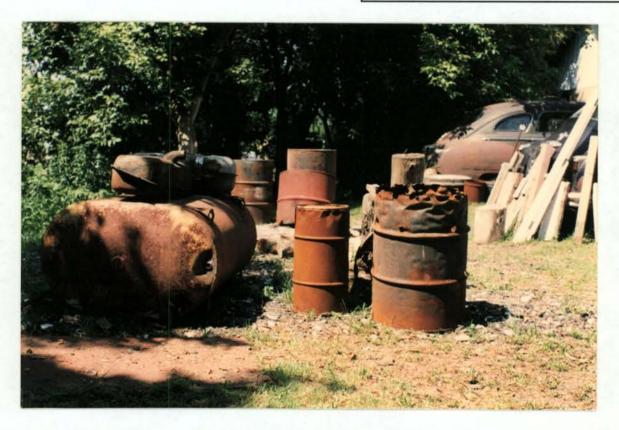
ology and environment, inc. HOTOGRAPHIC RECORD
Client: EPA Region III	E & E Job No.: ZE5629
Site: Fred's Auto Junkyard	
Camera: Make Pentax	SN 4759340 (EPA Decal 897603)
Lens Type 50 mm	SN 367638
	Photographer: J. McCall Date: 8/26/93
	Time: 1153 Frame No.: 16
	Comments*: Several drums and empty tanks located south
	of the garage. Used automotive oil filters are burned in
	these drums.
	*Comments to include location.

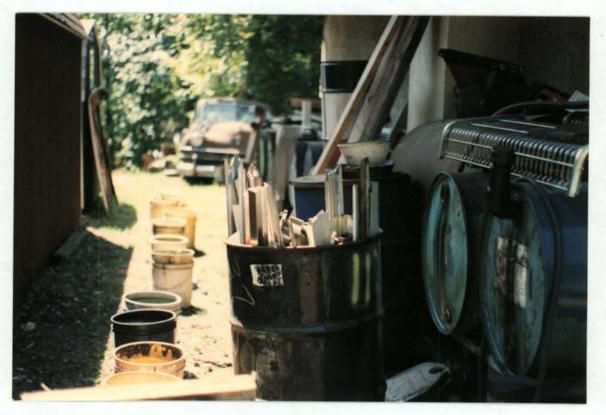
ecology and environment, inc. PHOTOGRAPHIC RECORD
Client: EPA Region III	E & E Job No.: ZE5629
Site: Fred's Auto Junkyard	
Camera: Make Pentax	SN 4759340 (EPA Decal 897603)
Lens Type 50 mm	SN 367638
	Photographer: J. McCall Date: 8/26/93
	Time: 1154 Frame No.: 17
	Comments*: Drums, heating oil tank, and buckets on east
	side of the garage. Drums are used to hold waste automotive
	motor oil or scraps. Buckets are used to collect rain water.
	*Comments to include location.
